Repair of a canine patellar ligament rupture using the ComPact UniLock 2.4/3.0 mm System

A. Gutbrod¹, K. Kühn², T. Wiestner³, P. Kircher², K. Hurter¹

¹Department of Small Animal Surgery, ²Section of Diagnostic Imaging and ³Equine Department, University of Zurich

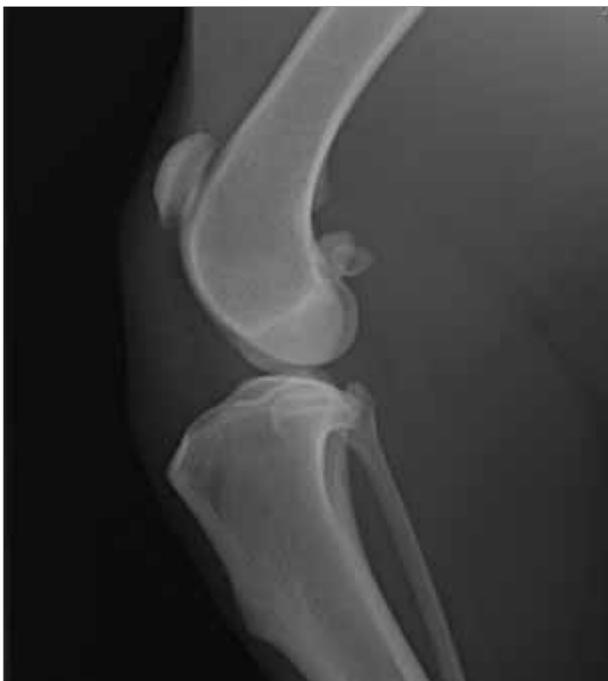
Figure 1: Pre-operative radiograph of the right stifle joint shows proximal displacement of the patella, a thickening of the patellar ligament and multiple small mineral opaque structures superimposed on mid and distal aspect of the patellar ligament.

Severe swelling of the left stifle, a proximally displaced patella and a depression cranial at the level of the patellar ligament were noted. No neurologic deficits or further lameness was detected. Radiographs of both stifle joints (Fig. 1) and an ultrasonographic examination of the left patellar ligament were performed to confirm the clinical diagnosis of patellar ligament rupture. To minimize the risk of infection surgical repair of the patellar ligament was delayed for 10 days.

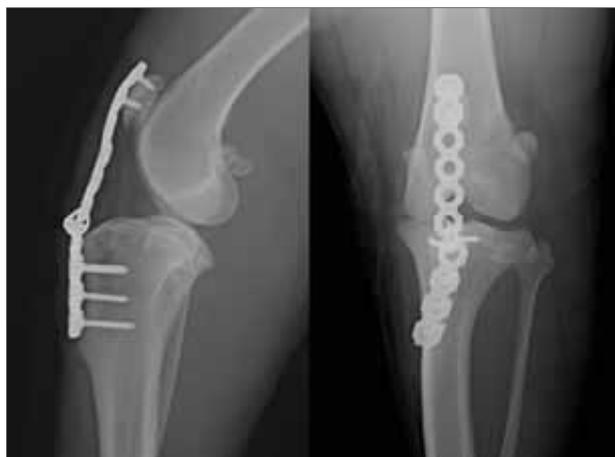
Figure 2: Laterolateral and caudocranial post-operative radiographs showing the ComPact UniLock 2.4/3.0 mm plates fixed to the patella and tibial tuberosity, respectively, connected with two orthopaedic wires. The appropriate distance of the apex patellae and the insertion of the patellar ligament at the tibial tuberosity is restored.

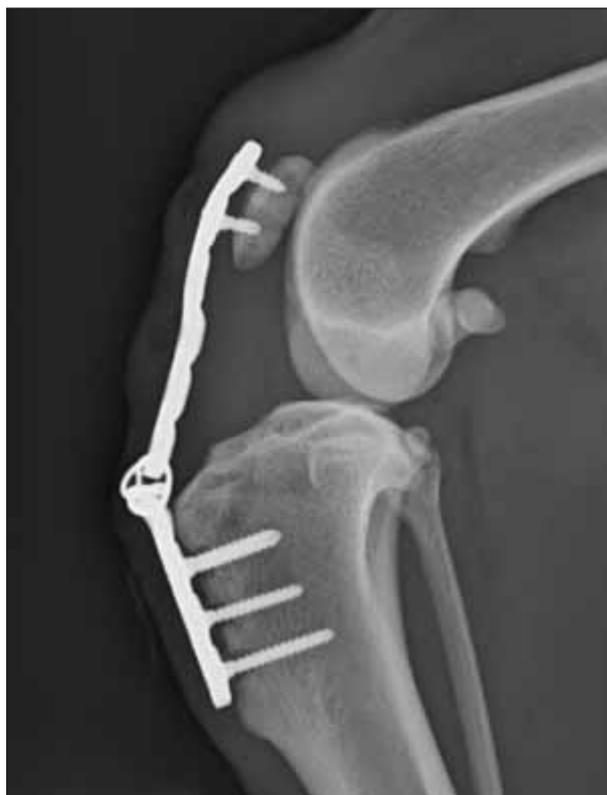
Figure 3: Radiograph 7 weeks after surgery shows well defined lucencies around the screws in the patella and less obviously around the base of the 3 tibial screws. There was a slight increase of the distance between the proximal part of the plate and the patella.

The orthopaedic exam on the first day after surgery showed only an intermittent and consistently weight bearing lameness of the left hind limb with normal joint angles during walk. The temporal-spatial gait analysis showed a reduction for the asymmetry indices for the TPI and the activated sensors compared to preoperative values. This indicated an improved weight bearing in the operated leg (Tab. 1). Three days after surgery the lameness gradually worsened and cytology after fine needle aspiration of the periarticular tissue showed a purulent inflammation with degenerated neutrophils and coagulase negative staphylococci were isolated resistant to the antibiotics the dog received. The antibiotic treatment was switched to clindamycin (Antirobe®, Pfizer AG, Zürich, Switzerland) and the leg was placed in a modified Robert-Jones bandage for 2 days. The swelling decreased within 2 days and the gait improved markedly to an intermittent and consistently weight bearing lameness again. For the next 7 weeks on weekly clinical exams and according to the owner no lameness was observed. The temporal-spatial gait analysis at this time also showed a reduction for the asymmetry indices for the TPI and the activated sensors compared to preoperative values. All implants were removed after 7 weeks, since radiographic examinations (Fig. 3) showed signs of implant loosening.
